Ecology

Part 1a: Description of Vegetation Compartments

ENVIRONMENTAL STATEMENT
 2021

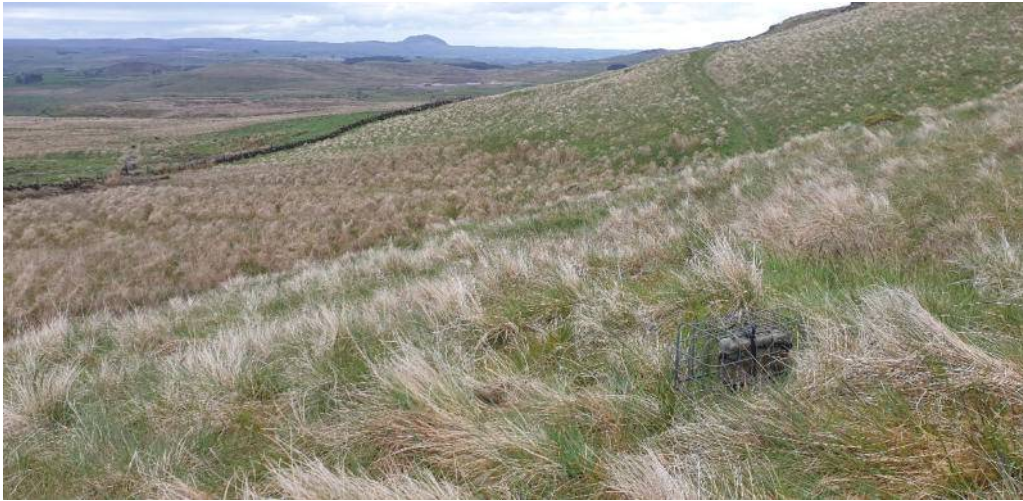
T1

Anabat Express with v3 microphone deployed at turbine location.

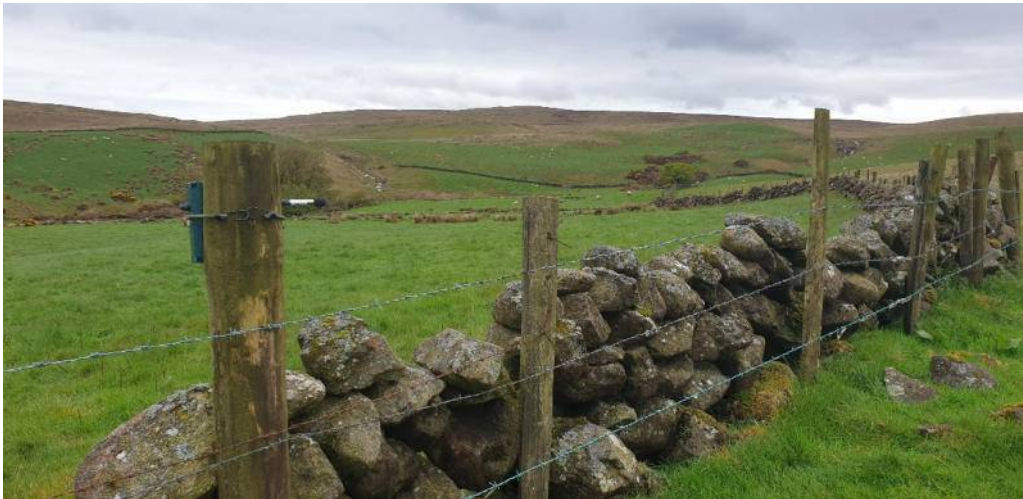
T6

SM2 Bat+ (Full Spectrum) with SMX-U1 microphone deployed at turbine location.

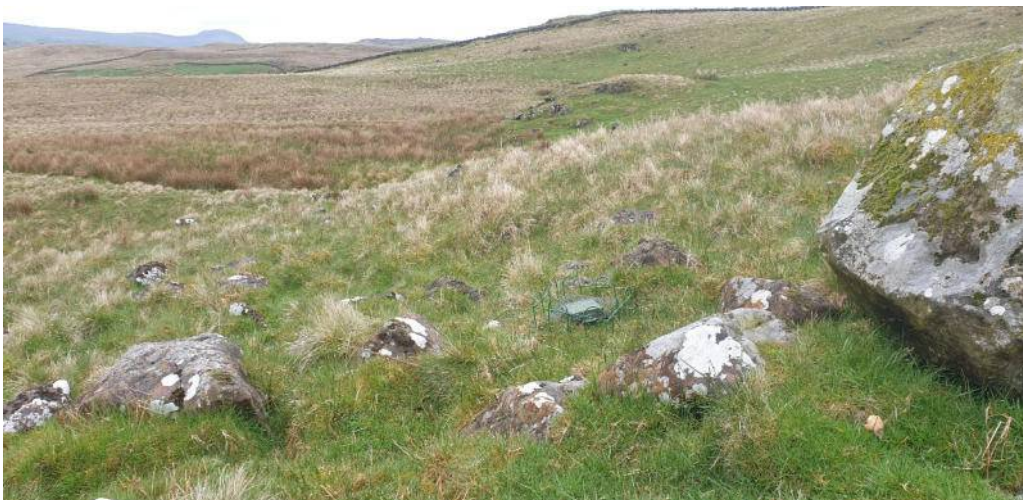
T7

SM4 ZC with SMM-U1 microphone deployed at turbine location.

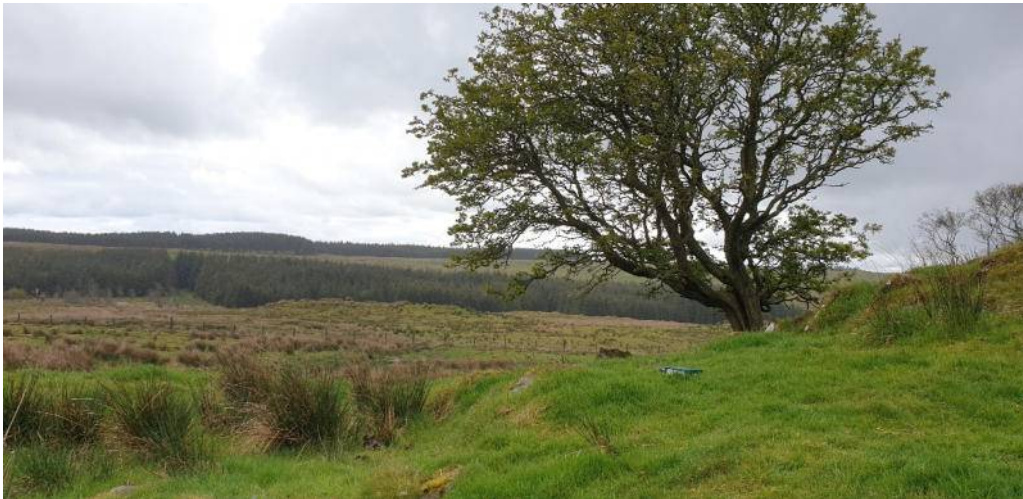
T9

SM2 Bat+ with SMX-U1 microphone deployed at turbine location.

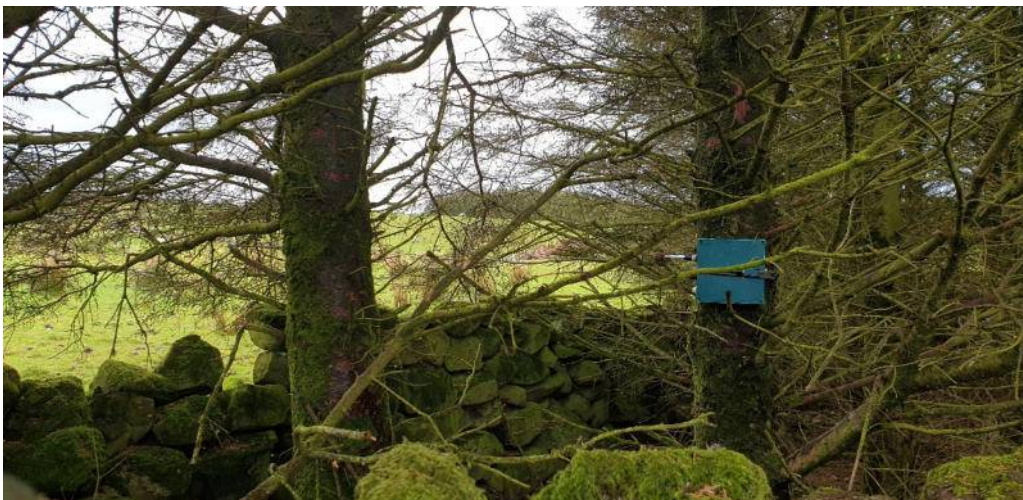
T10

SM2 Bat+ with SMX-U1 microphone deployed at turbine location.

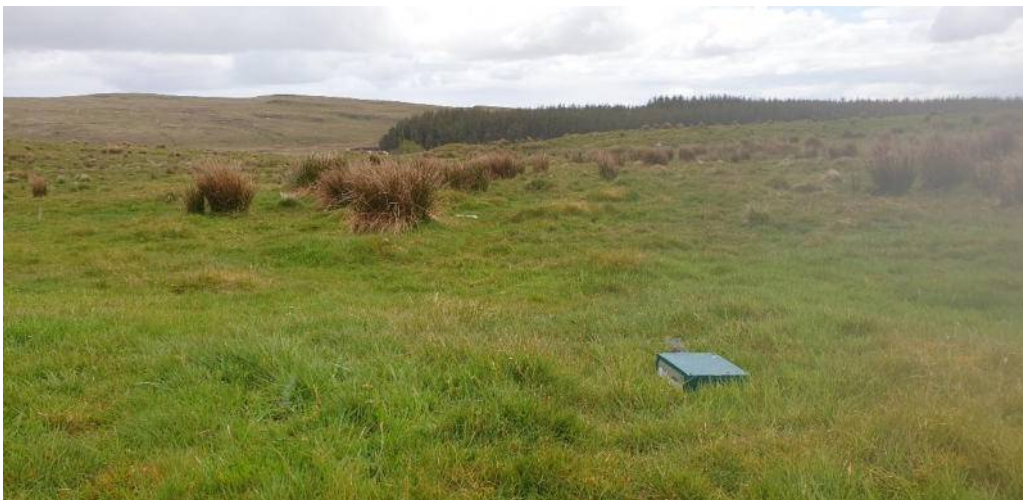
T14

SM2 Bat+ with SMX-U1 microphone deployed at turbine location.

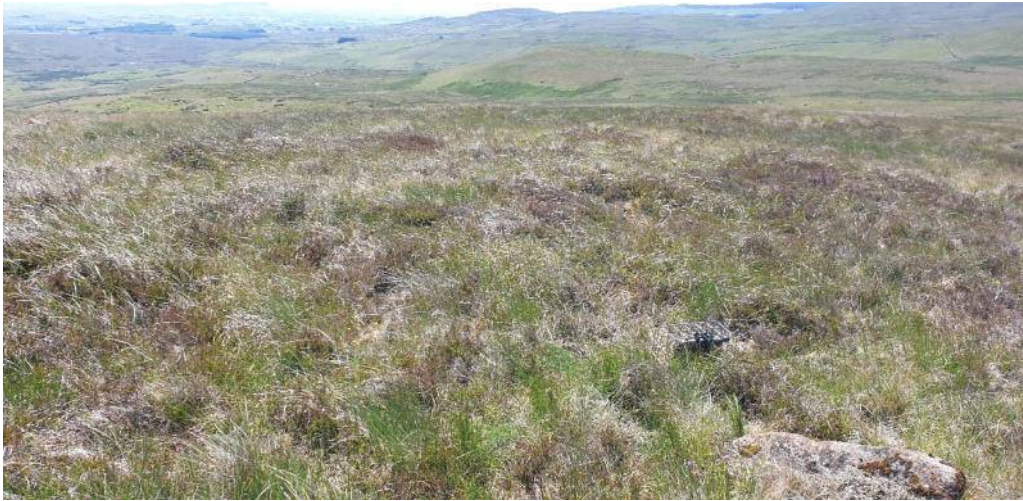
T2

Anabat Express with v3 microphone deployed at turbine Location.

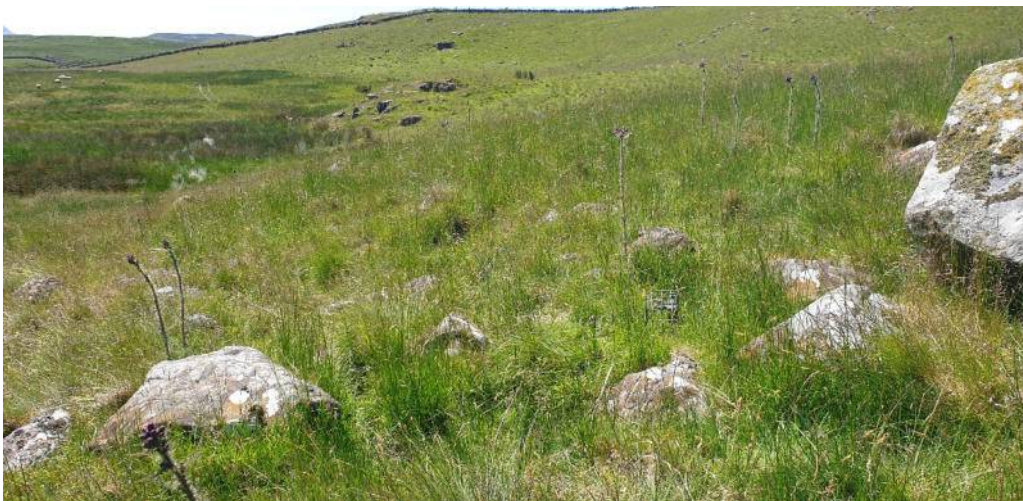
T7

Anabat Express with v3 microphone deployed at turbine Location.

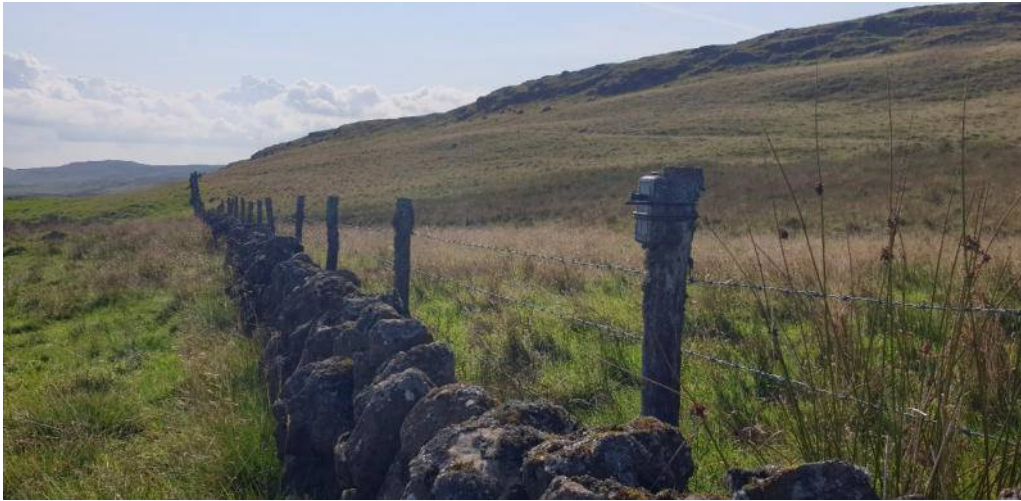
T1

Anabat Express with v3 microphone deployed close to turbine Location.

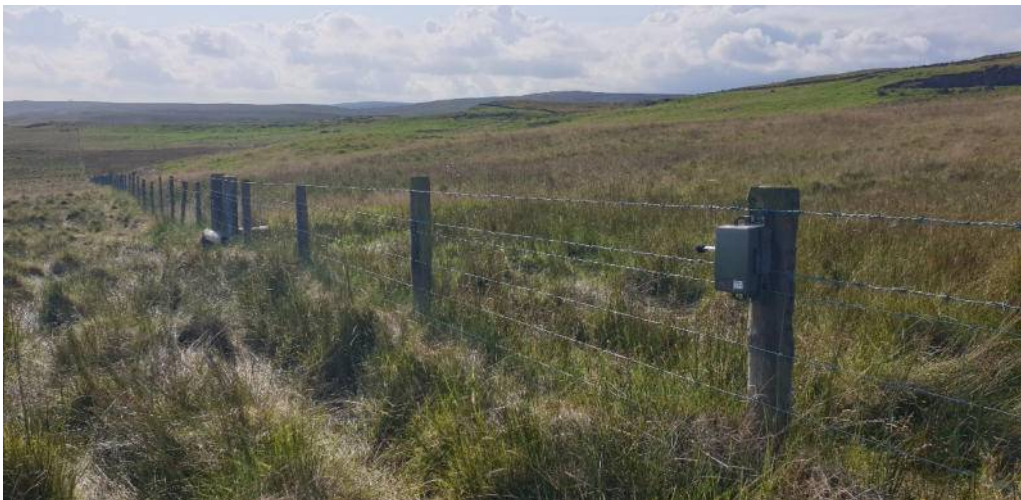
T3

SM4 ZC with SMM-U1 microphone close to turbine Location.

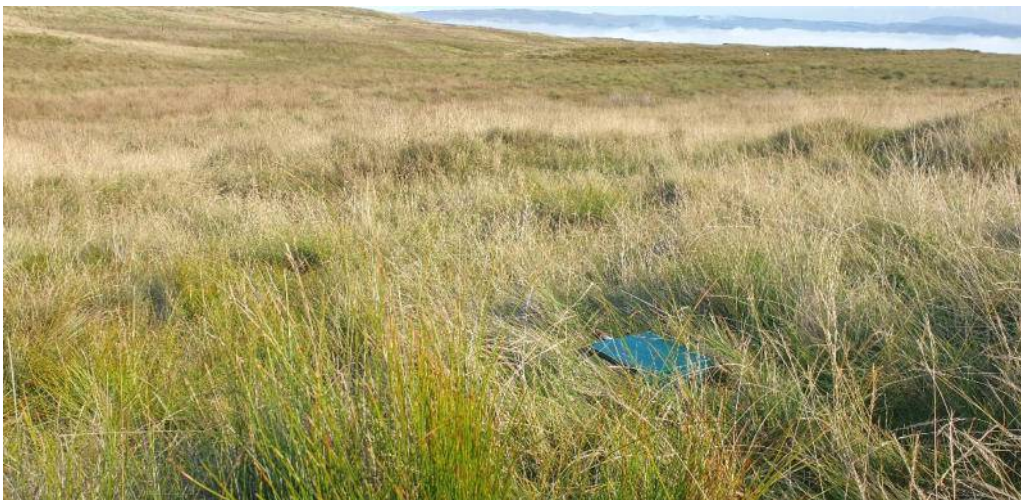
T4

SM2 Bat+ with SMX-U1 microphone deployed at turbine Location.

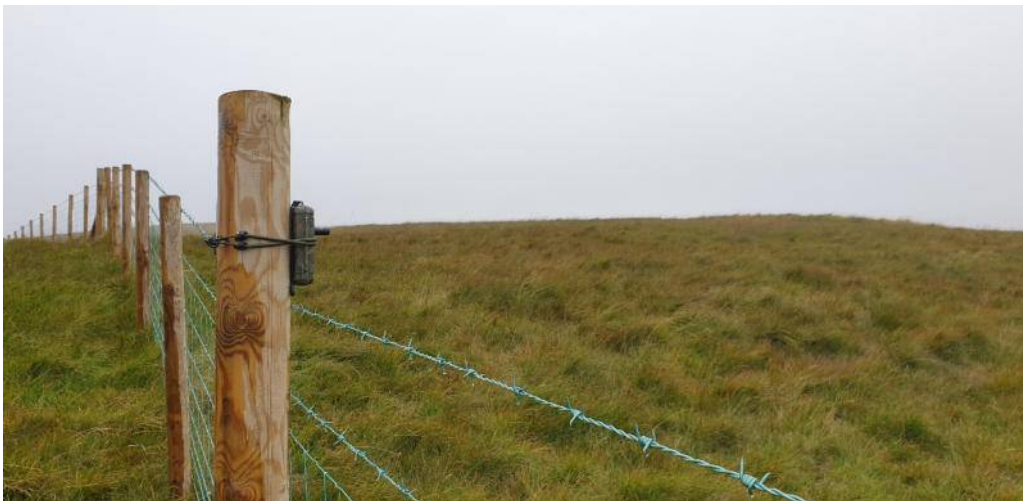
T7

Anabat Express with v3 microphone deployed close to turbine Location.

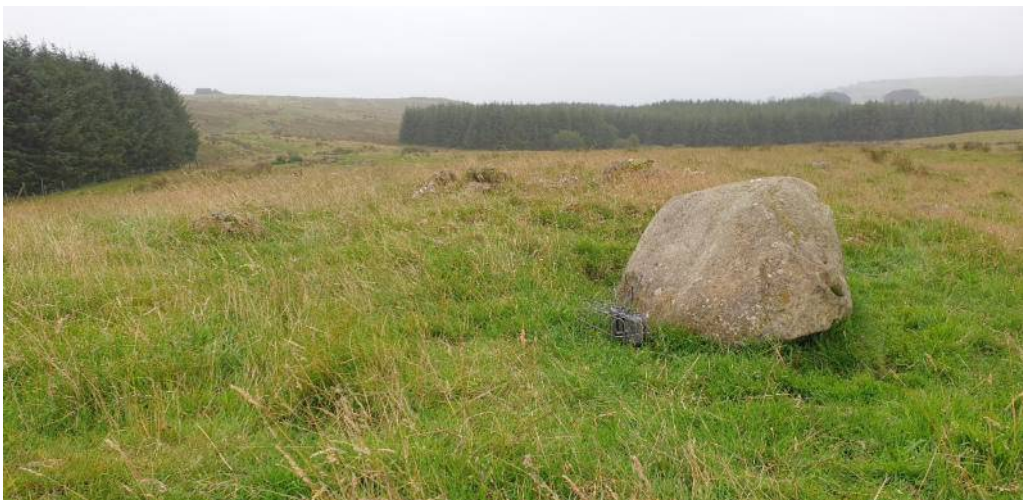
T10

Anabat Express with v3 microphone deployed at turbine Location.

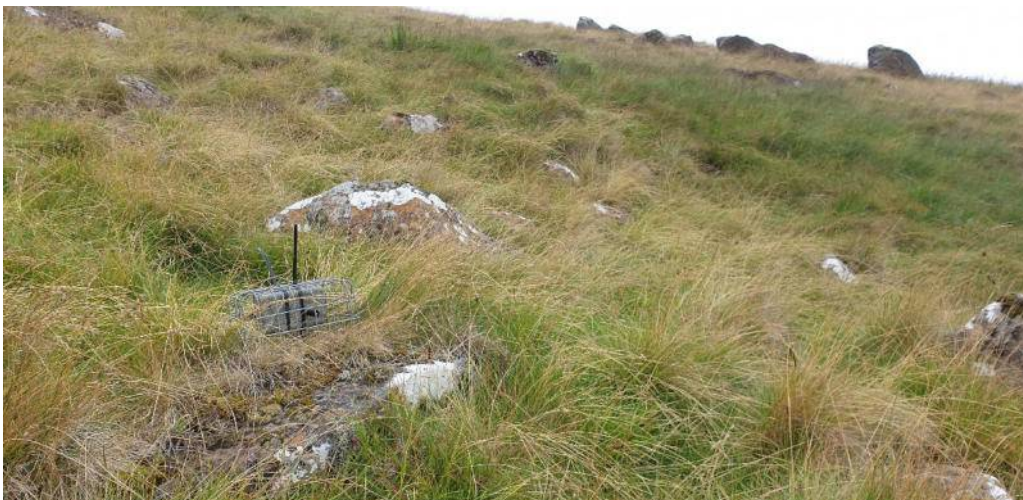
T13

Anabat Express with v3 microphone deployed at turbine Location.

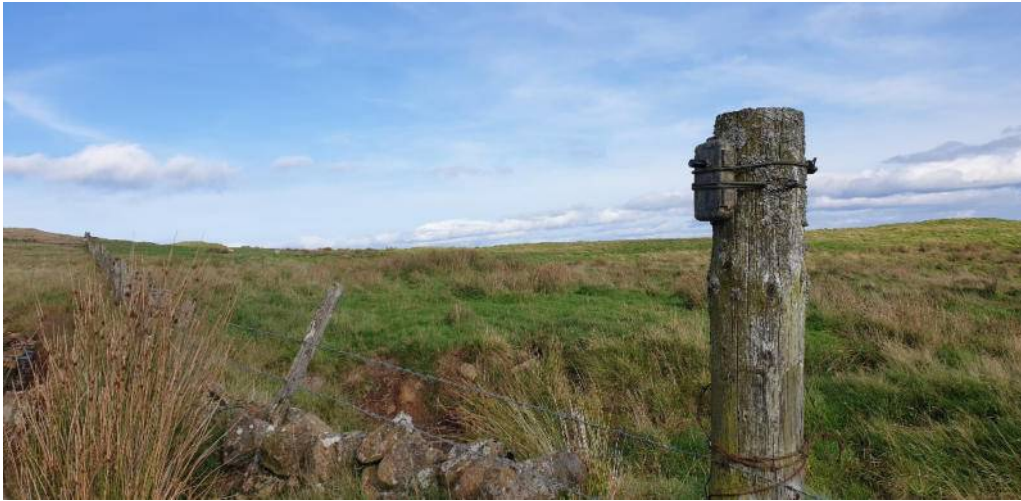
T1

Anabat Express with v3 microphone deployed close to turbine Location.

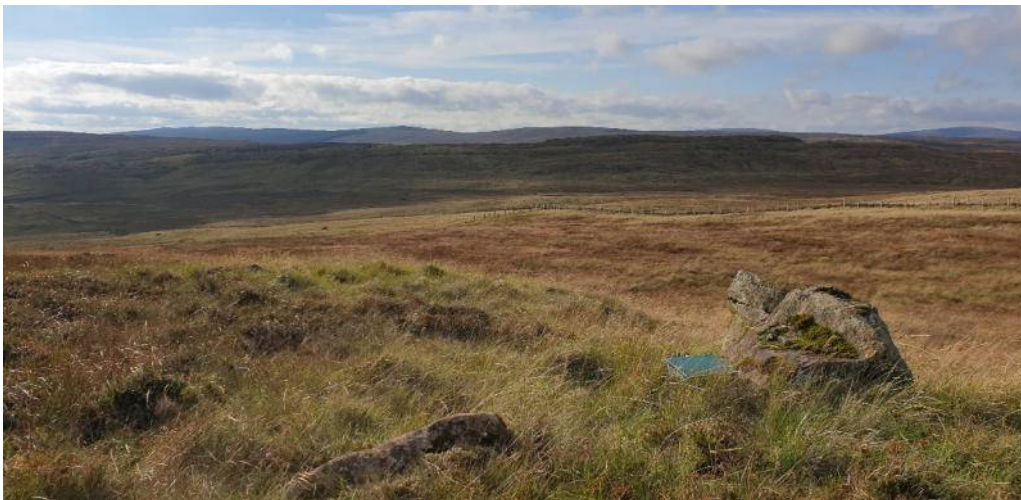
T2

SM2 Bat+ with SMX-U1 microphone deployed at turbine Location.

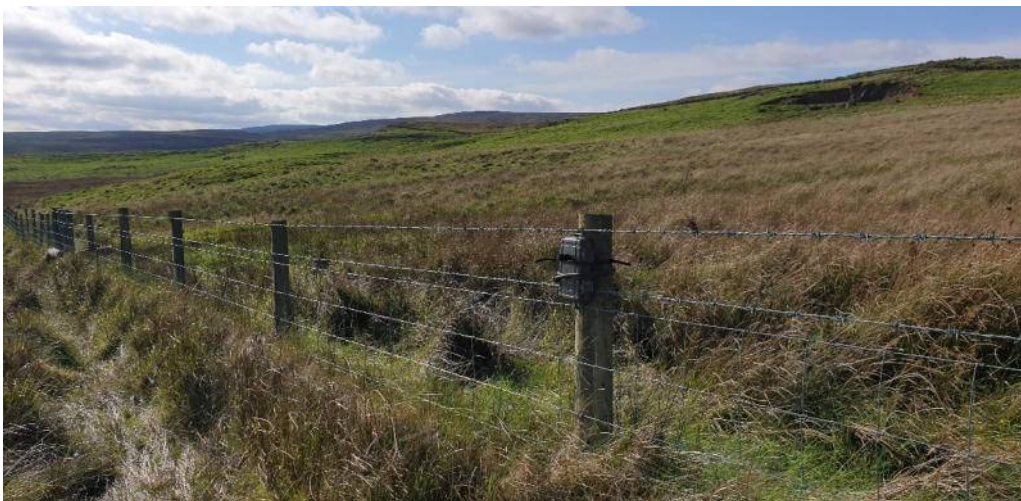
T3

Anabat Express with v3 microphone close to turbine Location.

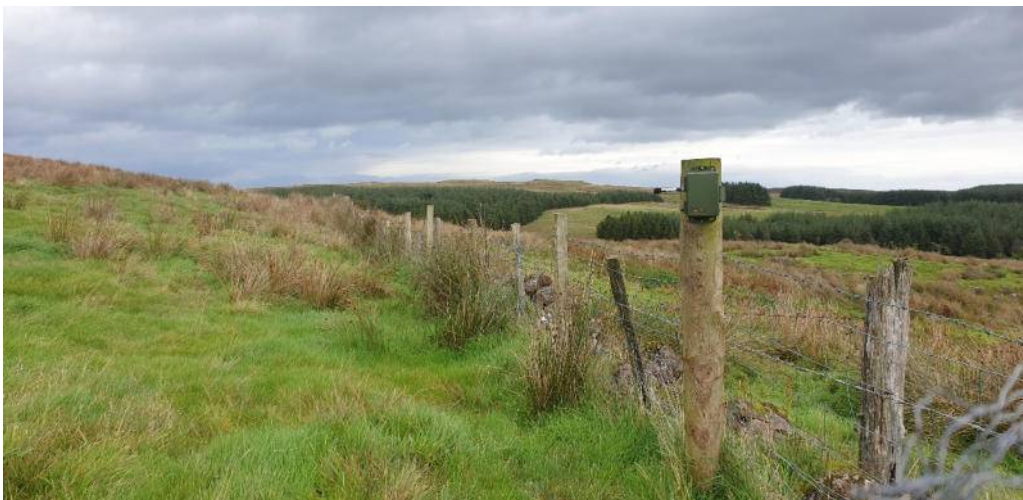
T11

SM4 ZC with SMM-U1 microphone deployed close to turbine Location.

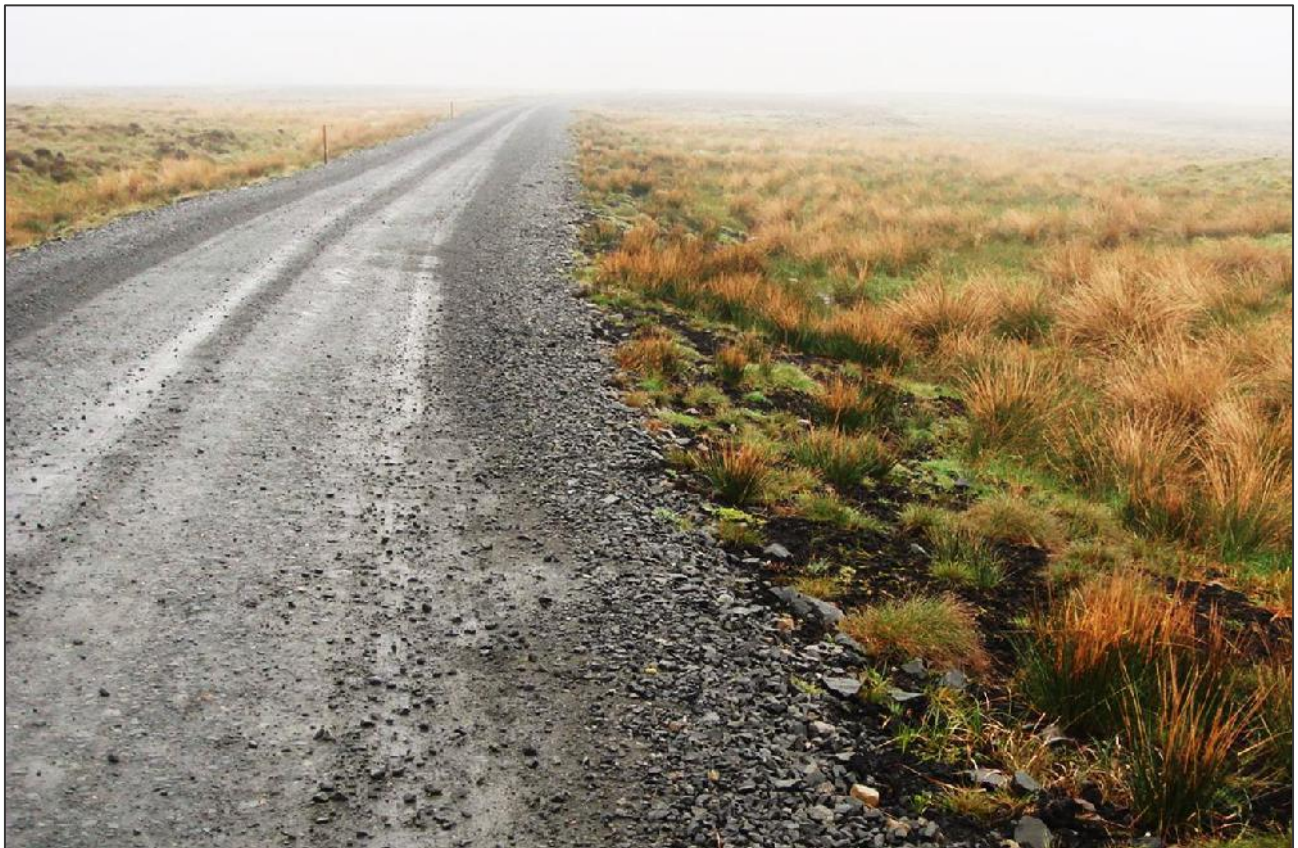
Figure 5.1: Effective Turf Management and subsequent re-establishment of verge

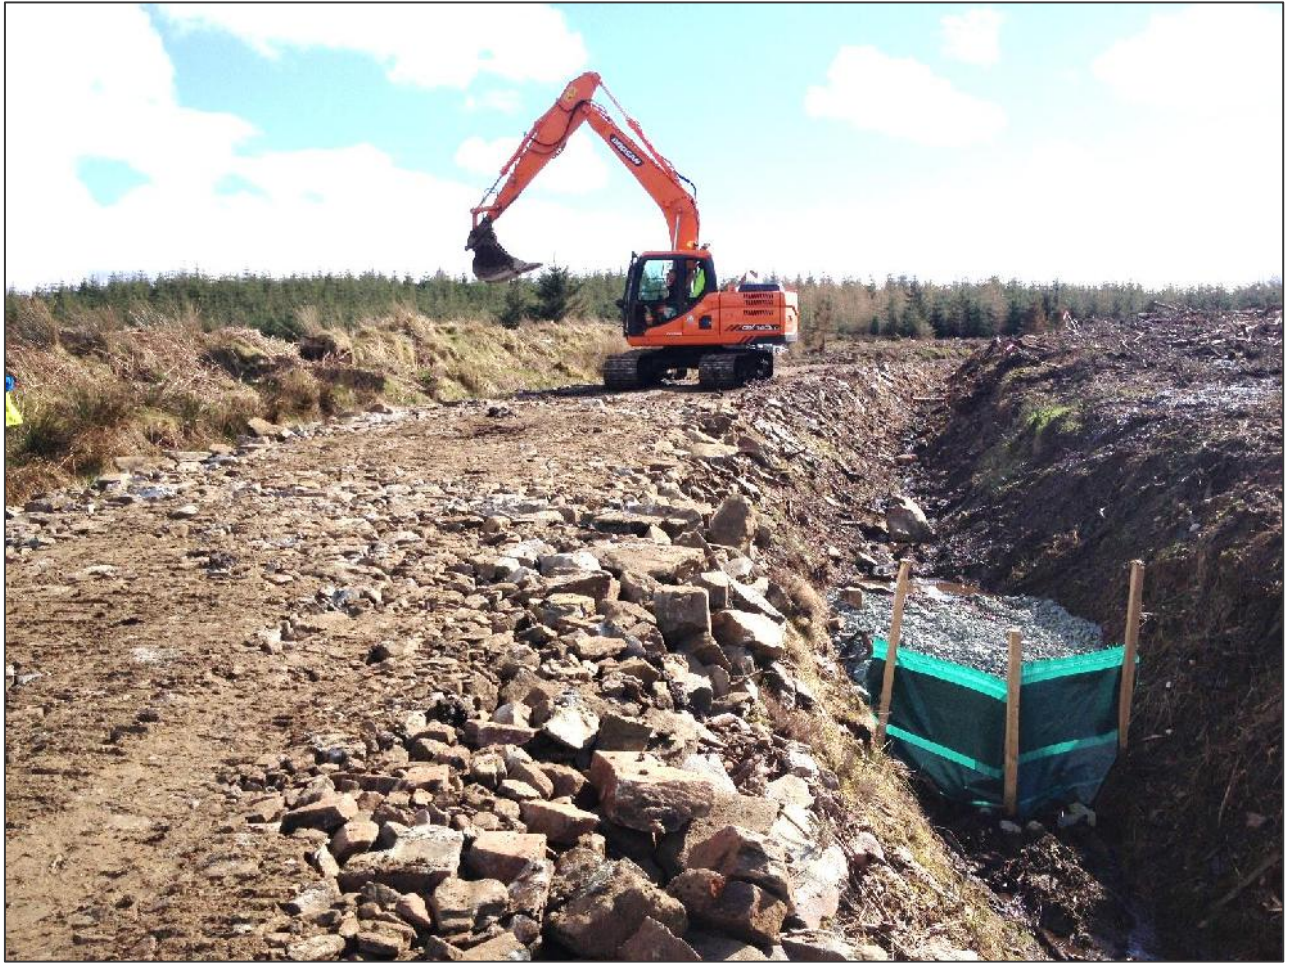
Figure 5.2: Example of verge reinstatement ongoing with drainage provision

Where cut and fill tracks are required in areas of peat or remnant peat habitat, then reinstatement will involve laying subsoil peat on the cut batters and then placing peat turves and clods on top of this. Reinstatement will be completed as soon as possible following construction to minimise the risk of turf drying. Restoration will be carried out as track construction progresses (Figure 5.2).

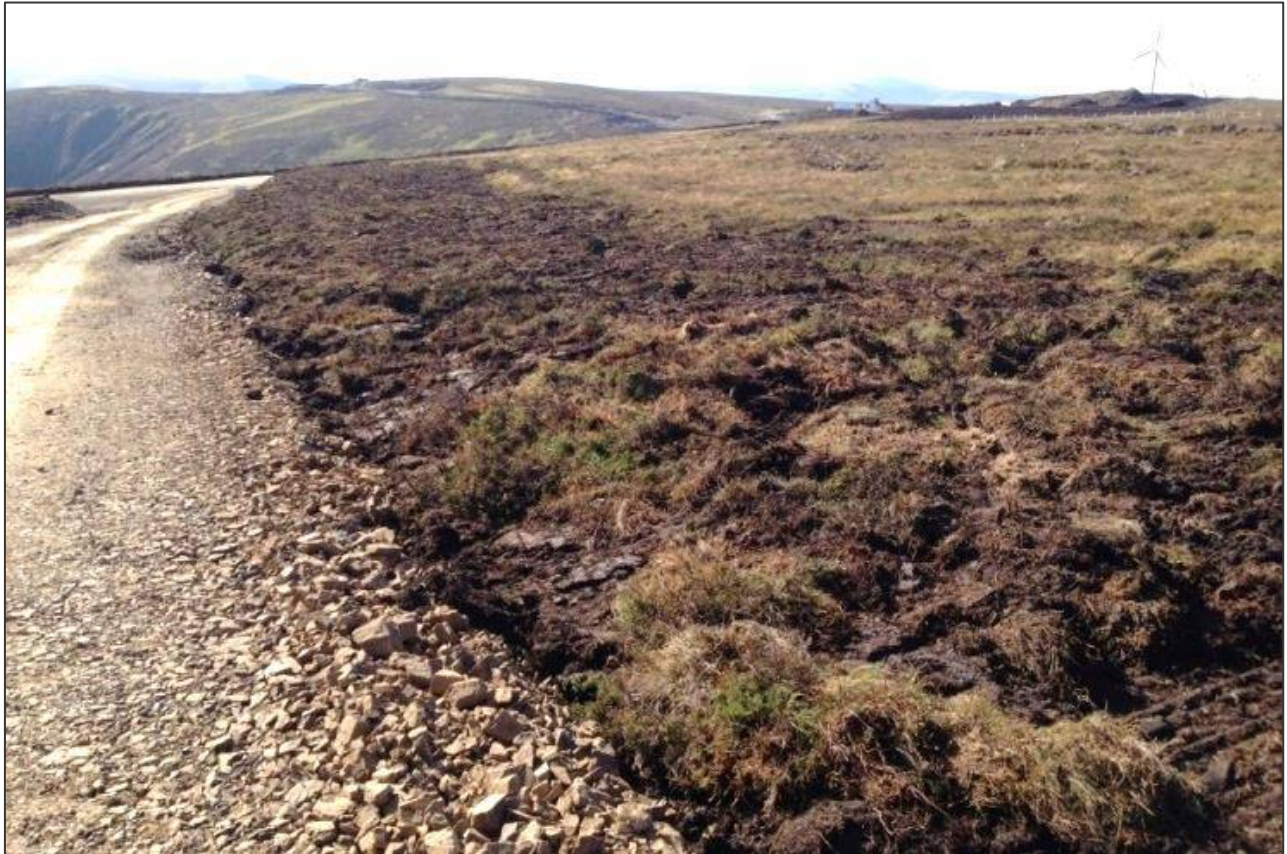
Figure 5.3: Example of access track verge reinstatement

Peat will only be used to re-profile or finish off the edges of the track or where construction has damaged the surface layer (Figure 5.3). In order to re-establish vegetation in these areas as quickly as possible peat turves will be utilised wherever practical.

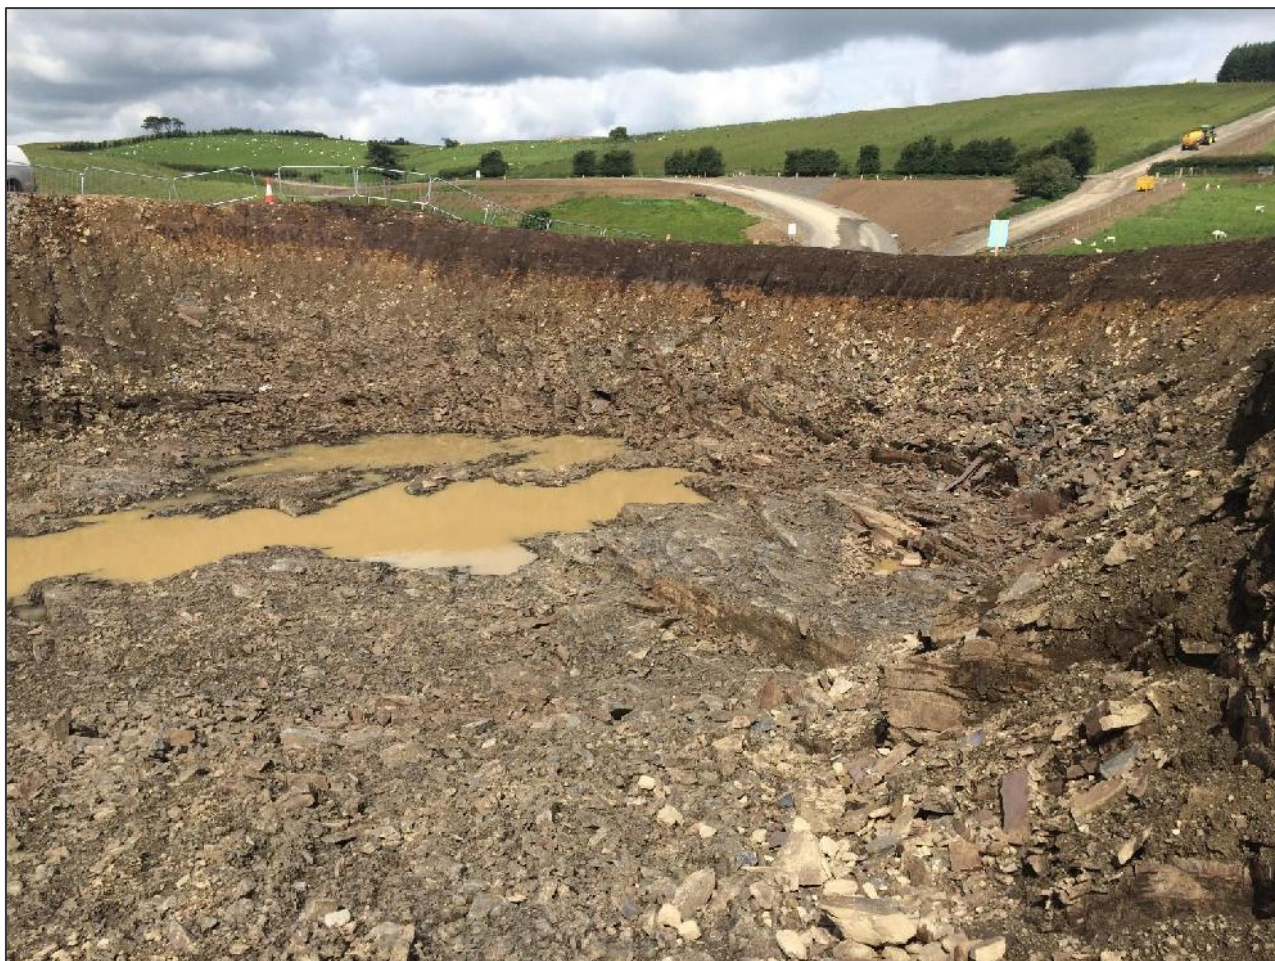
Figure 5.5: Excavated material stockpiled around the perimeter of the foundation excavation

The turbine foundations will be backfilled with the excavated material. Not all excavated material will be suitable for backfilling or reinstatement. The previously stripped and stored soils, and vegetated layers or turves will then be spread over the disturbed area, caused by turbine foundation construction (Figure 5.6). Where turbine bases are constructed in peat, reinstatement will involve laying subsoil peat on the backfilled area and then placing the vegetated peat turves on top. Reinstatement will be carried out as soon as practically possible following completion of foundation construction to minimise the risk of turves/vegetated layers drying out.

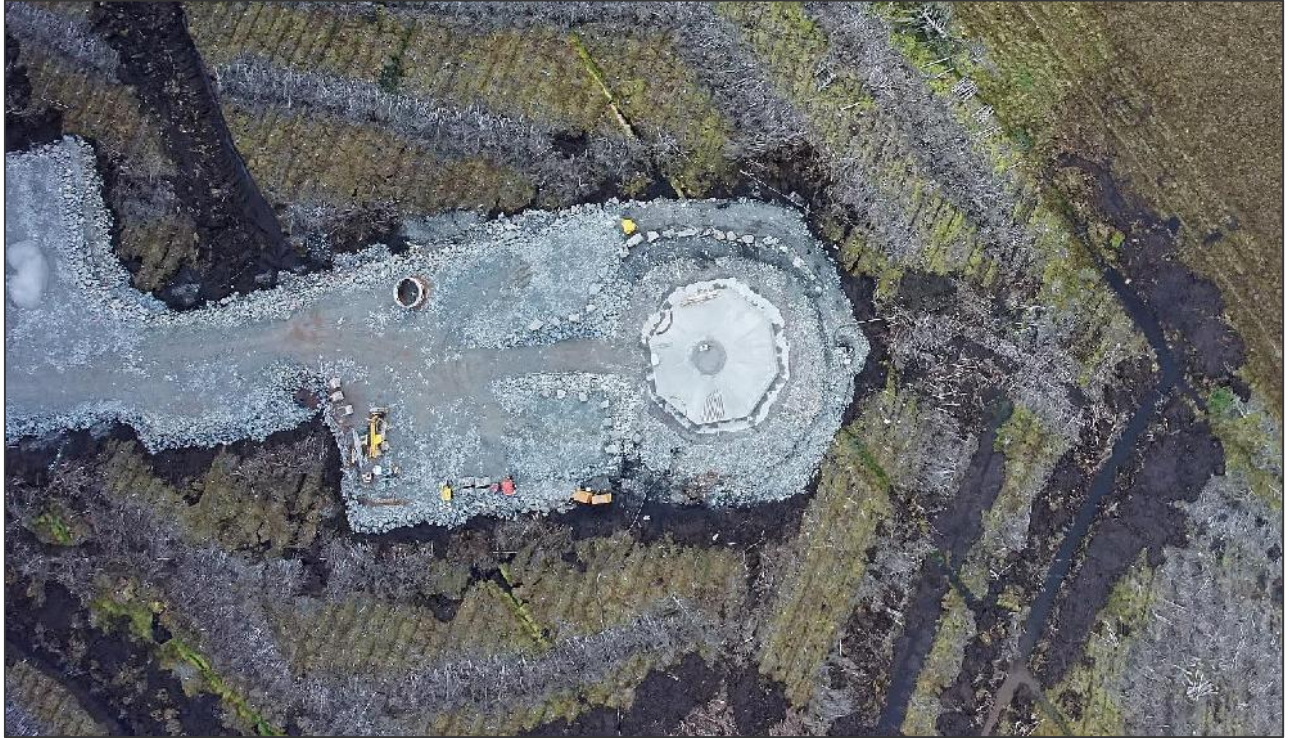
Figure 5.6: Minimising peat excavation through displacement construction methods.
