Technical Appendix 9.3.1: Geotechnical Assessment: Peat Slide Risk Assessment;

Unshinagh Wind Farm

Stage 2 - Peat Slide Risk Assessment

27 September 2021

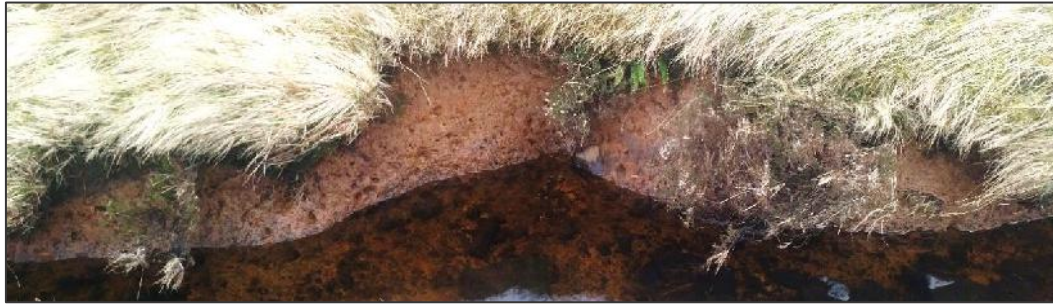
Figure 3.2: Example of glacial till exposed in a small stream

Source: NATURAL POWER site walkover (ING 324972, 415422)

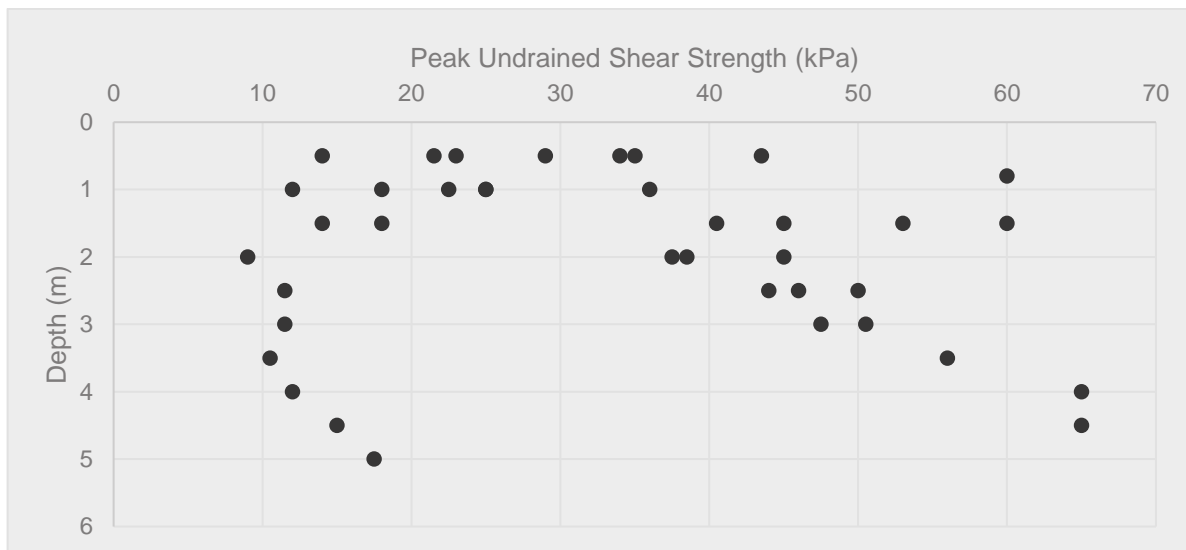
Figure 3.4: Peak undrained shear strength against depth across the site.

Figure 3.4 depicts the peak undrained shear strength data against depth.

The peat undrained shear strength is seen to be highly variable within the peat deposits with no clear trend against depth. In the absence of specific test readings at the majority of the turbine bases a very conservative value of 9kPa (extremely low strength) is considered appropriate for the site wide slope analysis.

x7 shear tests were carried out at core locations where peat depths allowed. Each test was carried out using a Geonor H-60 Hand Shear Vane Tester using a 33mm steel vane. **Error! Reference source not found.** shows the HSV results alongside the peat core information. Locations for each peat core are presented on Map A6 in the appendices.

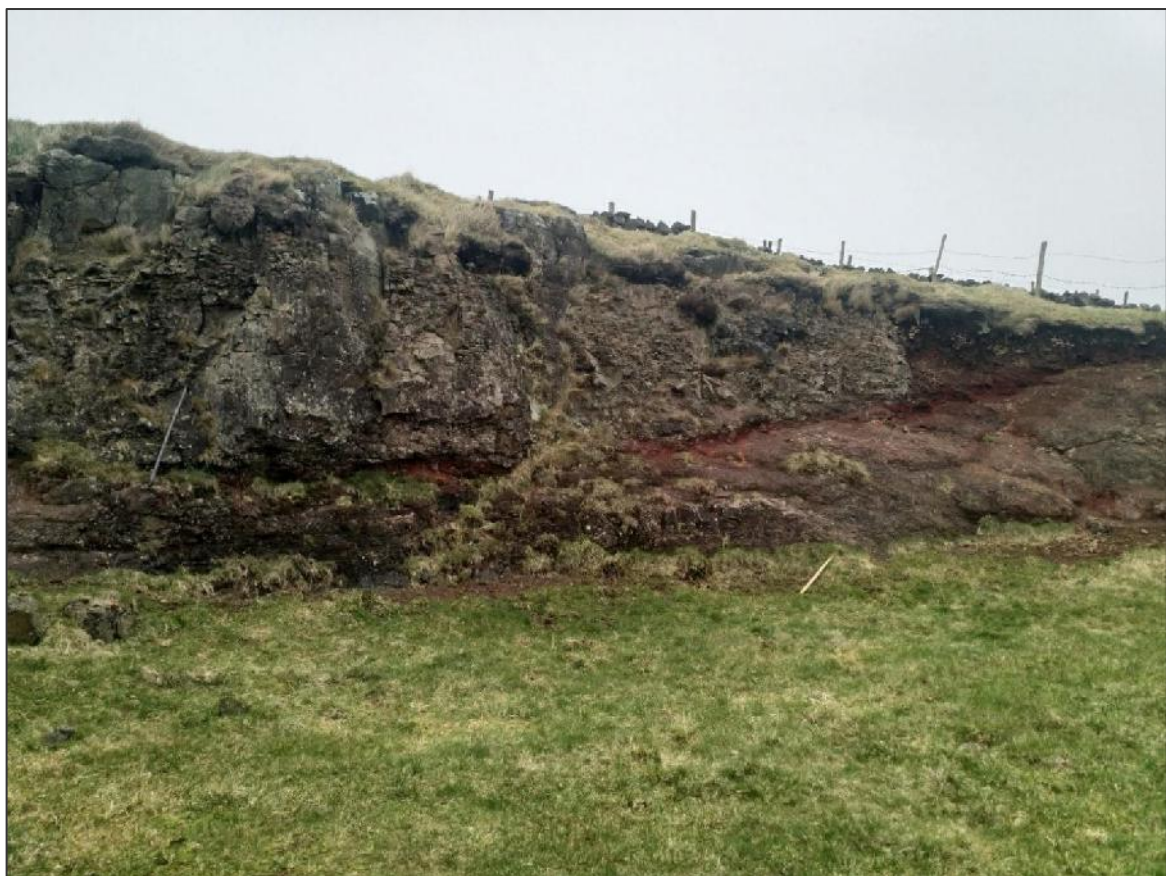
Figure 3.6: Lava flow covering underlying palaeosol

During the site survey x5 outcrops were noted to have exposed lava flows and palaeosols. Figure 3.6 shows a photo of one exposure. A 3m thick basaltic lava flow is shown to the left of the outcrop. This is overlying a red lens-like palaeosol on the right of the exposure. Examples of these are present throughout the site, and likely extend below the surface.

The basalt is very strong, and generally massive with frequent fractures. The palaeosol material is highly weathered, weak to medium strong, highly fractured. The extent of these likely permeates throughout all the upper and lower basalts. More photos can be found in Section **Error! Reference source not found. Error! Reference source not found.**, outcrop locations are presented on Map A3.

Presence of these geological features will require a targeted ground investigation to inform the foundation design.
